State of Illinois
ENVIRONMENTAL PROTECTION AGENCY
MEMORANDUM

DATE: August 23, 2011
TO: Division Files - Bureau of Land
FROM: Chris Cahnovsky – Collinsville Region
SUBJECT: 1198010003 – Madison County
Estate of Chemetco
FOS File

FOUNDRY BUILDING DEMOLITION

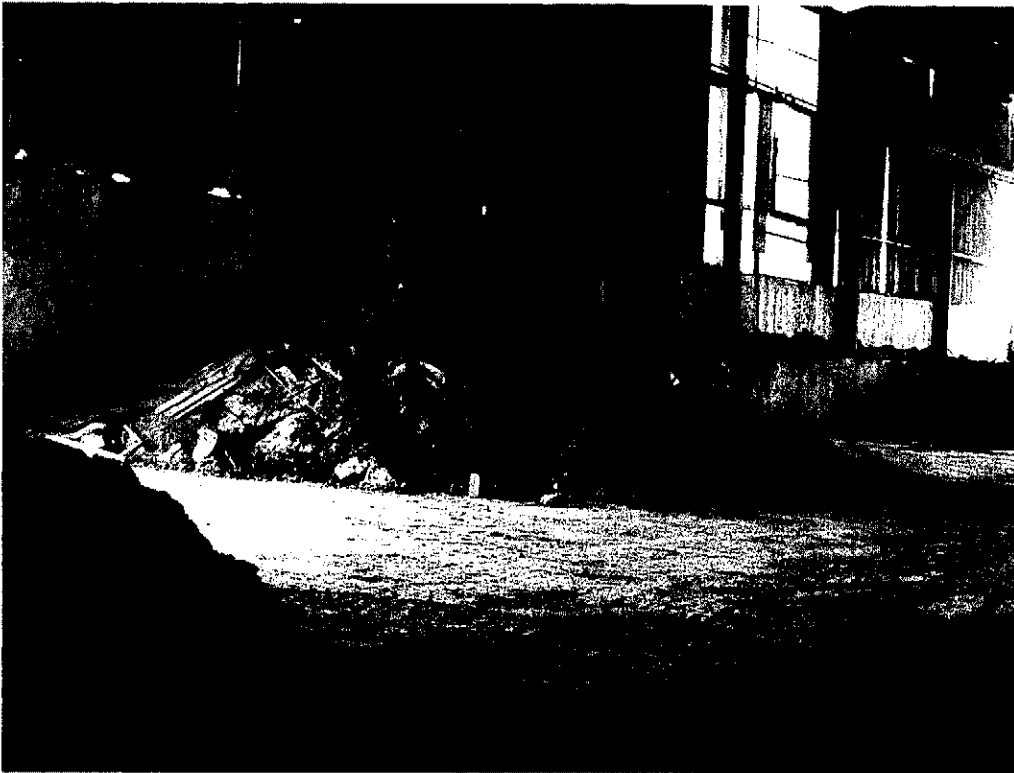
The purpose of this inspection was to inspect the beams, walls, roof trusses and the foundry mezzanine level. According to Mr. Murray, AIS has nearly completed the removal of the dust and furnace fines from these areas. In the foundry along the west wall I observed three large piles of dust that had been removed from the beams, walls, roof trusses, from around furnace and mezzanine level. The fines have been segregated into three piles. One was dust from the beams and duct work that contained a small amount of debris. The second pile was from the floor and around the furnaces. This pile needed to be screened to remove debris. The third pile was mixed fines and also contained debris that needed to be screened.

Date: 08/15/2011
Time: 1:15 – 2:30
Direction: Northwest
Photo by: Chris
Cahnovsky
Exposure #: 001
Comments: Material
from cleanup of
floor around the
furnace

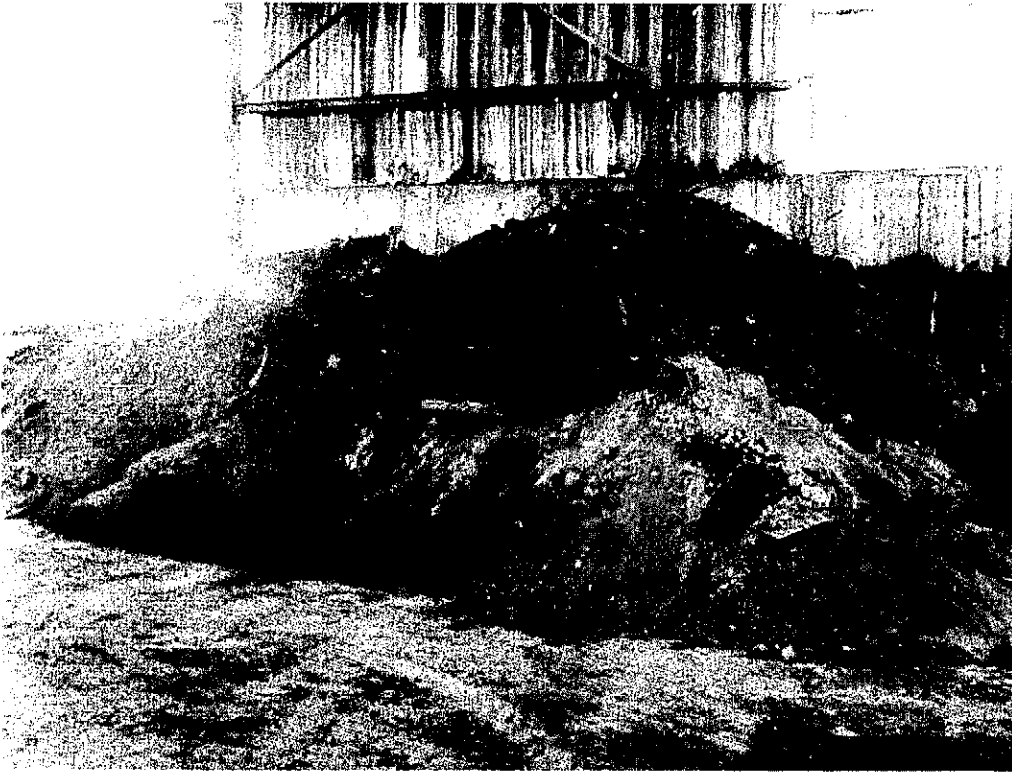
Date: 08/15/2011
Time: 1:15 – 2:30
Direction: Southwest
Photo by: Chris
Cahnovsky
Exposure #: 003
Comments: Material
from beams and
ledges

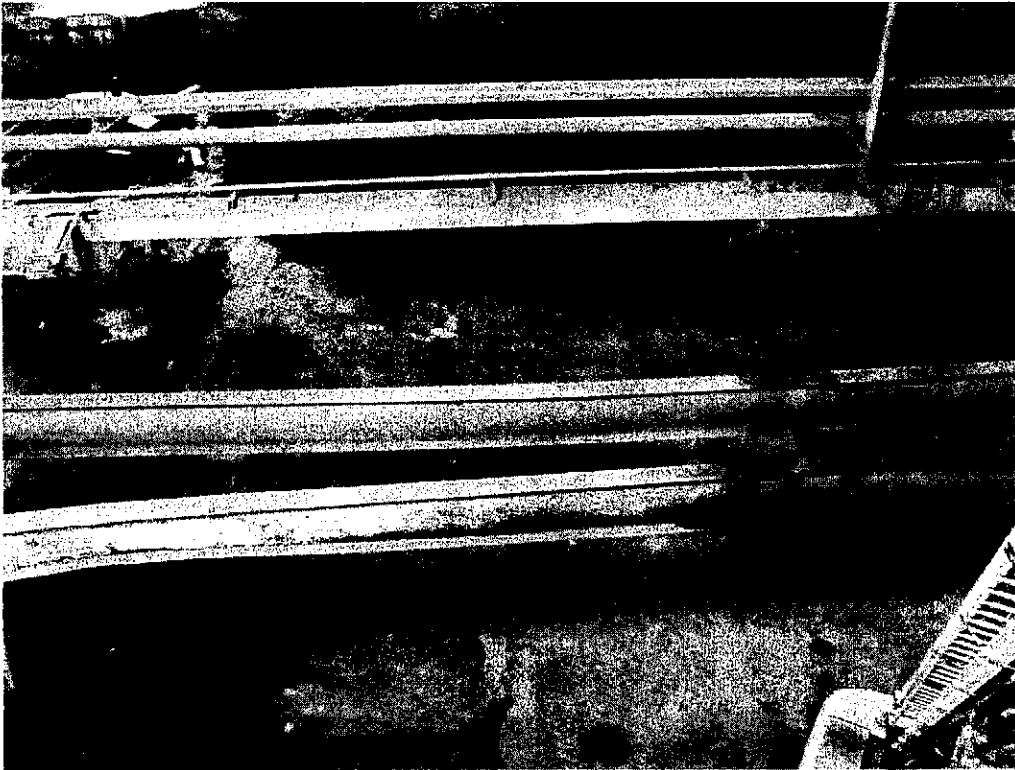
Date: 08/15/2011
Time: 1:15 – 2:30
Direction: West
Photo by: Chris
Cahnovsky
Exposure #: 005
Comments: Beams
that have been
cleaned

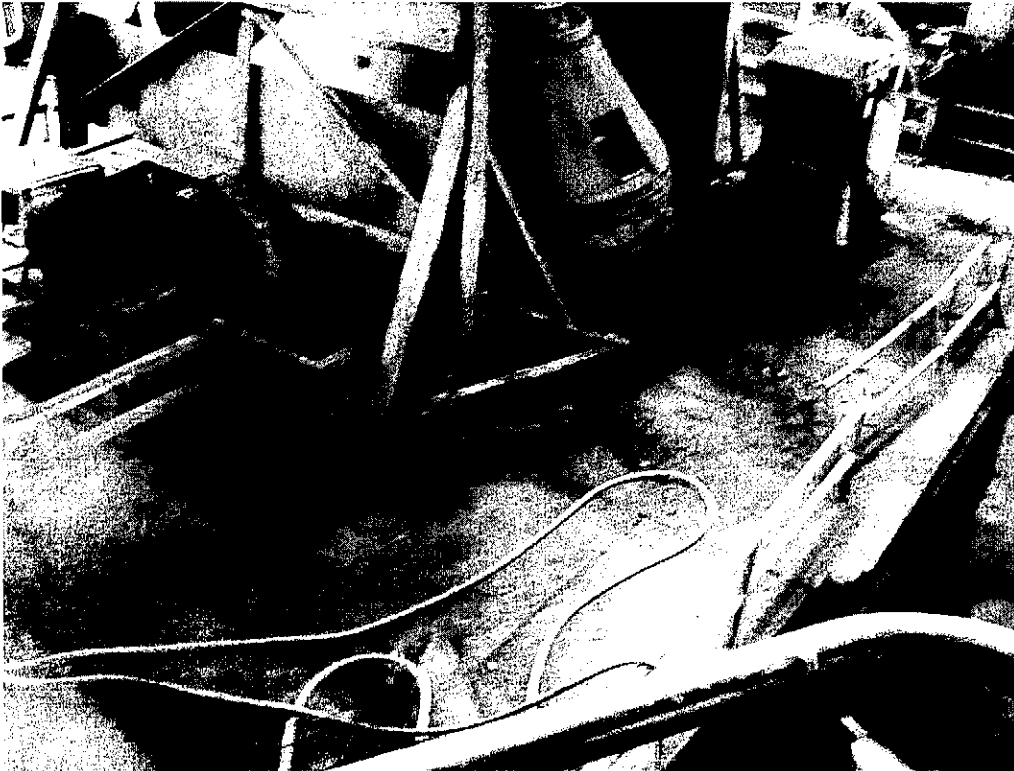
Date: 08/15/2011
Time: 1:15 – 2:30
Direction: Southwest
Photo by: Chris
Cahnovsky
Exposure #: 007
Comments: Second
floor foundry
mezzanine level
after first cleaning

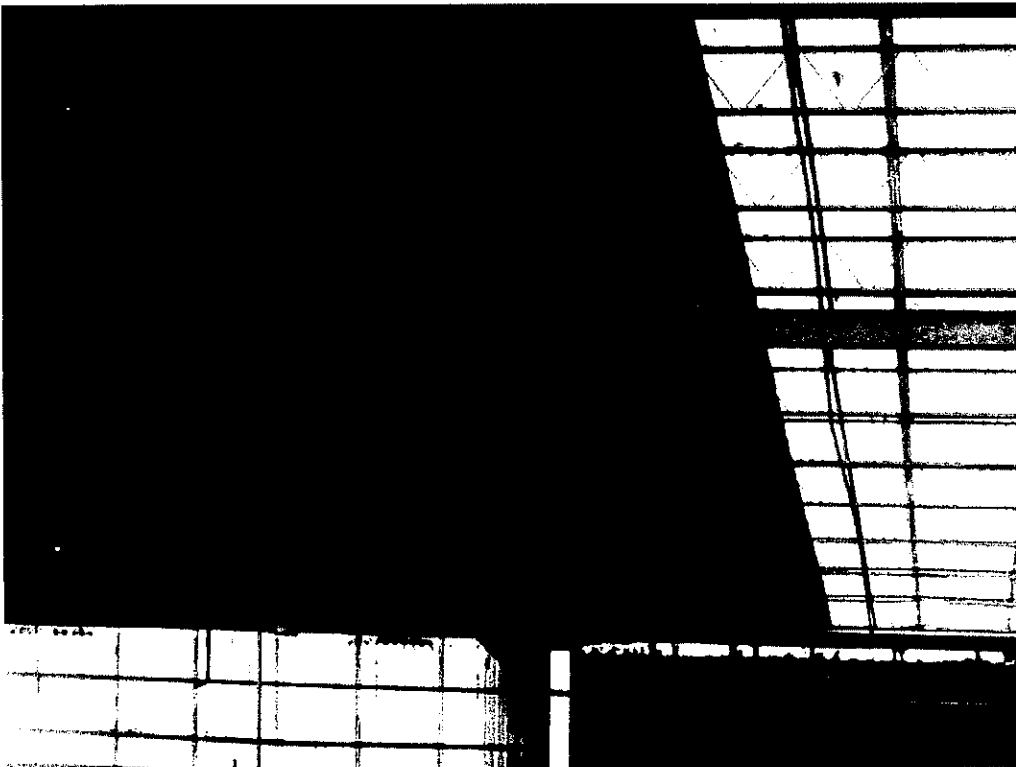
Date: 08/15/2011
Time: 1:15 – 2:30
Direction:
Photo by: Chris
Cahnovsky
Exposure #: 012
Comments: Beams
that have been
cleaned

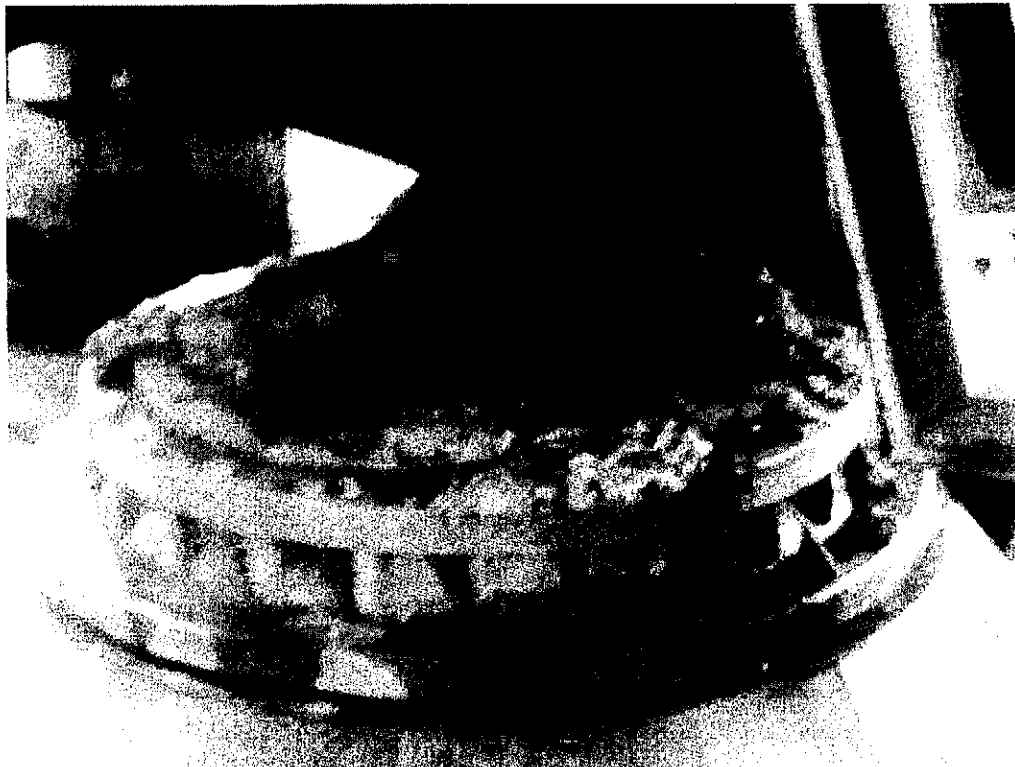
Date: 08/15/2011
Time: 1:15 – 2:30
Direction: West
Photo by: Chris
Cahnovsky
Exposure #: 014
Comments: Top of
furnace with baked
on solids

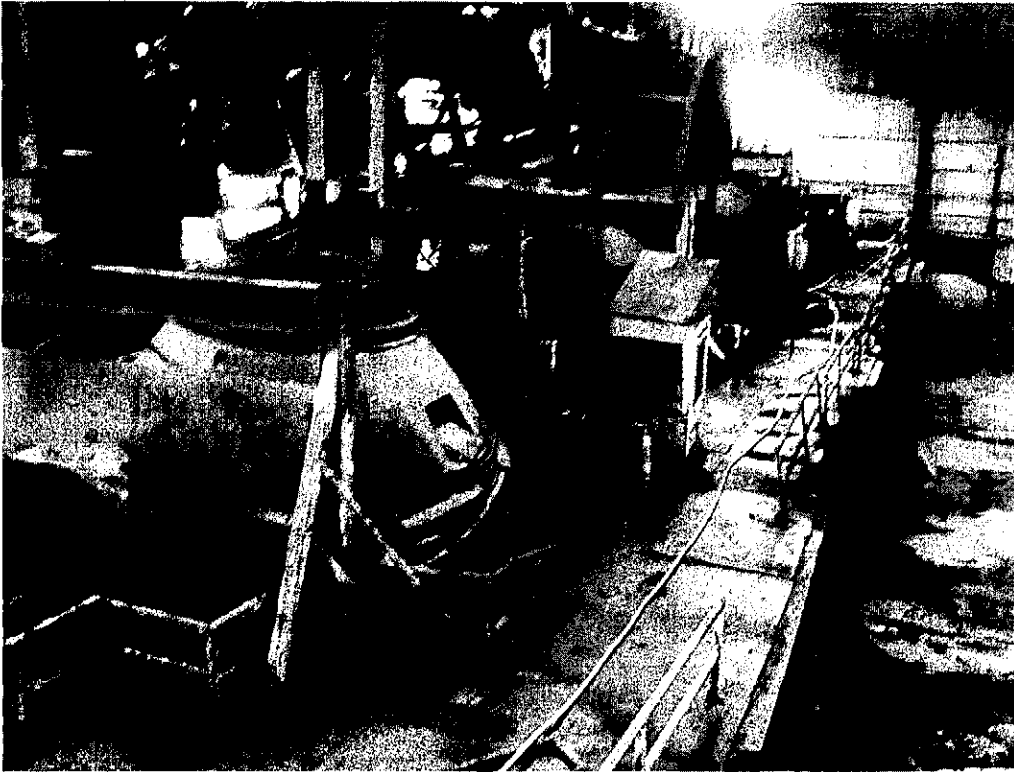
Date: 08/15/2011
Time: 1:15 – 2:30
Direction: South
Photo by: Chris
Cahnovsky
Exposure #: 017
Comments: Second
floor foundry
mezzanine level
after first cleaning
